Manhole Inspection Summary

Manhole # S43II_027MH

Insp Date: **4/24/08 8:59 AM**

Location Address: **Regester St**

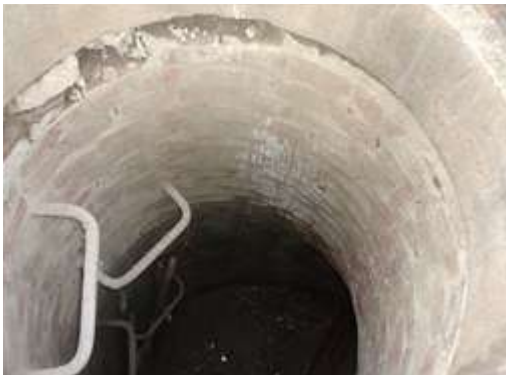
Defect 2

Condition: ☐ Sound ☐ Cracked ☐ Root Intrusion ☒ **Loose Brick** ☒ **Deteriorated**

loose bricks

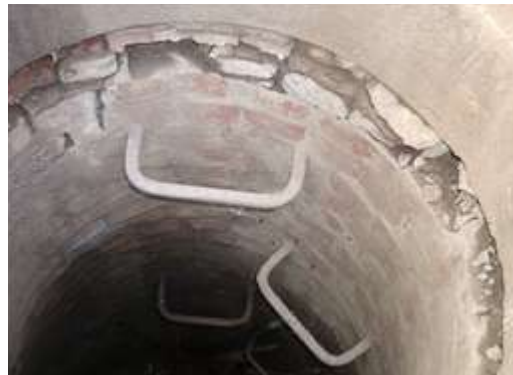
Defect 1

deterioration

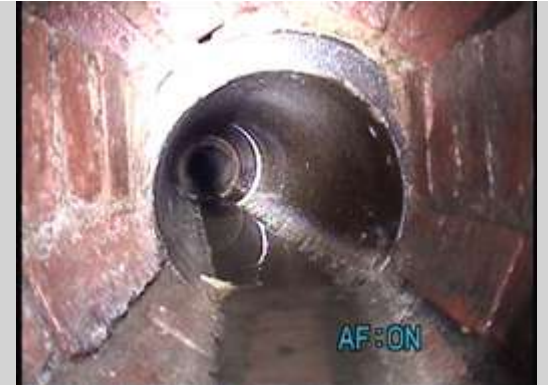
12 O'Clock Outflow

8 in. Circular Gravity Sewer
Pipe Out @ 12 O'Clock

Pipe Height: **8.4** (in.) Rod and Bar (Angled)
Pipe Material: **Clay** ☐ Pipe Lined
Invert Depth: **9.30** (ft.) Flow Characteristics: **Slow**
Deposits: ☒ None ☐ Mud ☐ Sludge ☐ Debris ☐ Grease
Silt Depth: (in.) Deposits Extent:
Infiltration: **None** Pipe Seal Cond: **Sound**

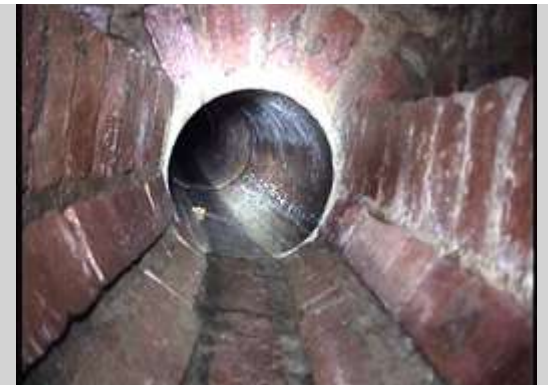
6 O'Clock Inflow

8 in. Circular Gravity Sewer
Pipe In @ 6 O'Clock

Pipe Height: **8.4** (in.) Rod and Bar (Angled)
Pipe Material: **Clay** ☐ Pipe Lined
Invert Depth: **9.40** (ft.) Flow Characteristics: **Slow**
Deposits: ☒ None ☐ Mud ☐ Sludge ☐ Debris ☐ Grease
Silt Depth: (in.) Deposits Extent:
Infiltration: **None** Pipe Seal Cond: **Sound**
